A bad-capacitor story ends happily

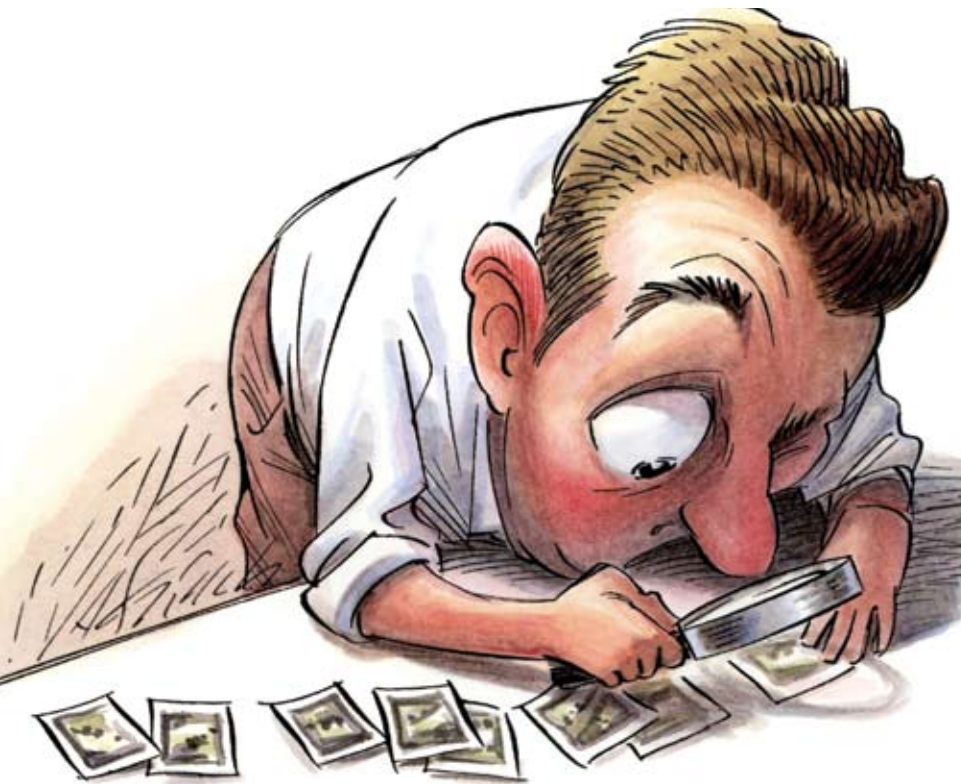
I received a module whose source of failure was easily identifiable: a charred tantalum capacitor. It failed short, making the whole multithousand-dollar module nonoperational. This surface-mount capacitor—with a 7343 footprint and 20V rating—was sitting on a 12V-dc plane. This failure rate of one capacitor in about 10,000 pieces in this time span was well below the statistical prediction. I took a picture of the fallen capacitor and considered the case closed.

The idea of a temperature rise due to ripple current causing the failure gained traction when all three photos of the fallen capacitors revealed a common condition: almost no solder on each negative terminal. The electrical connection was still good, but there was little solder. The capacitor's positive terminal was fine with a fair amount of curvature-profiled solder. I started to promote the idea that the lack of solder had caused impeded thermal contact, but it was only wishful thinking. I calculated the worst ripple current: 10% of the maximum rating. On an operational board, I got less than 5%.

I had already dismissed other ideas—from excessive humidity to airflow turbulence. Suddenly, the picture of the layout popped up in my mind. The layout sections for the five good capacitors were identical: Vias were close to both terminals going down to an internal layer. The bad capacitor had a via at the positive terminal, but, at the negative end, there was a heavy trace going *inside* the footprint, *beneath* the capacitor, and *only then* outside. That's when I knew how to fit together all the pieces of the puzzle.

On the positive terminal, the solder stayed where it was supposed to, clinching the terminal to the PCB (printed-circuit board). On the negative side, however, during assembly, the melted solder drifted under the capacitor and solidified, lifting the negative end and bending the capacitor just enough to create a microcrack—a capacitor's well-known nemesis. I never felt as much excitement writing a technical report as I did the next day. **EDN**
