Filter-feedthrough-failure flash

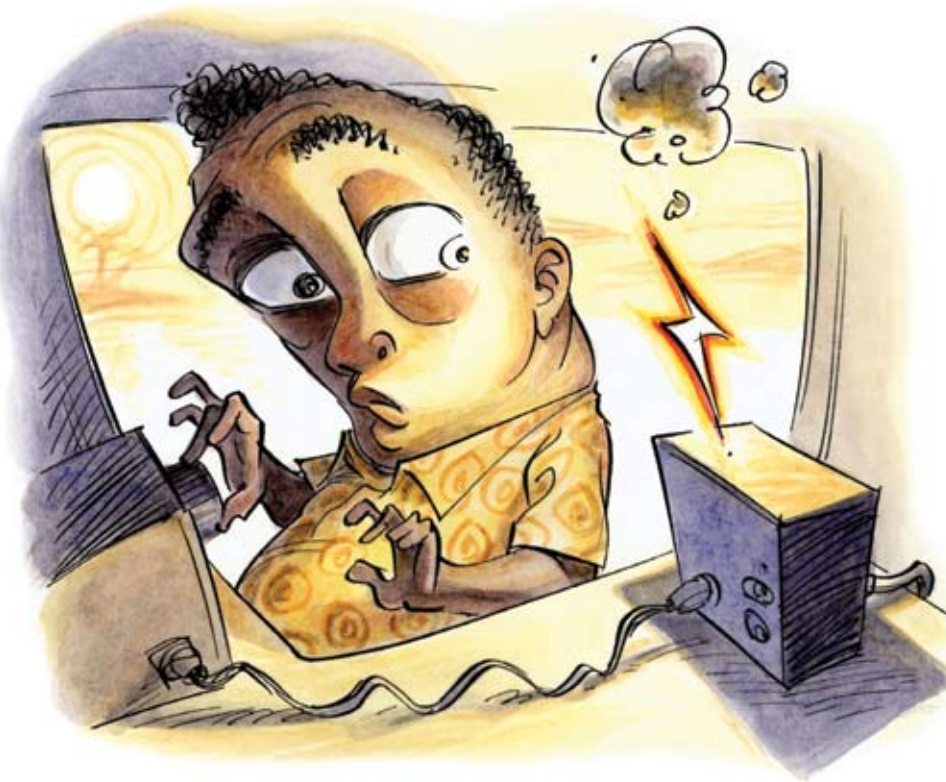
When I installed myself in the lab and began to evaluate the failures, I found that they were almost all because of shorted filter feedthroughs. To further investigate the cause of the feedthrough failures, I applied the rated voltage to one of the shorted units. It flashed like a small bolt of lightning. I thought I had blown it completely, but further testing revealed that I had “fixed” it; it was no longer shorted and still functioned as a filter. Further microscopic examination of other failed units revealed a silver path on the surface of the insulator that had been formed in the humid environment of Indonesia as the silver plating on the body of the feedthrough migrated across to bridge the gap, driven by the dc voltage I had applied to the center pin. I was able to prevent further occurrences by applying conformal coating to the feedthroughs after the units were installed in the system.

Here’s a hint: As previously noted, you use filter feedthroughs to pass a voltage—usually with a dc component—through a housing wall to give RF isolation and an environmental seal against humidity. It stands to reason, then, that most filter feedthroughs spend at least some of their lives with a dc voltage applied and in a humid environment. In this common application, all silver-plated filter feedthroughs are destined to fail unless you further protect them from humidity by applying a conformal coating after soldering a wire to the center pin. A more practical approach is to specify feedthroughs with gold or palladium plating. **EDN**
