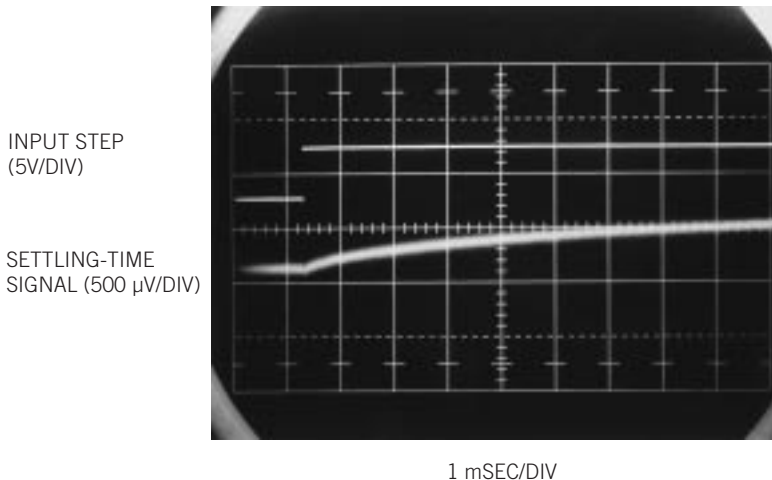
Figure 13

A poorly designed amplifier can exhibit a “thermal tail,” which is drift due to die heating, even after it appears that settling has occurred. In this case, loading the amplifier causes a thermal-tail error of 400 μ V, or greater than 2.5 LSB.
