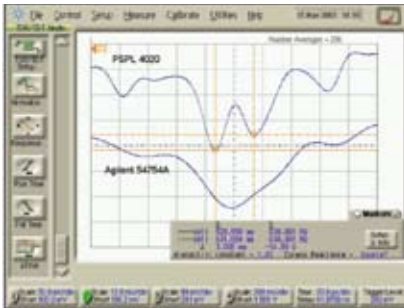
Figure 7 The two small wires in Figure 6 cause these dips in impedance. Using a 9-sec pulse generator causes the top trace, and the scope's internal pulse generator causes the bottom trace (courtesy Picosecond Pulse Labs).
