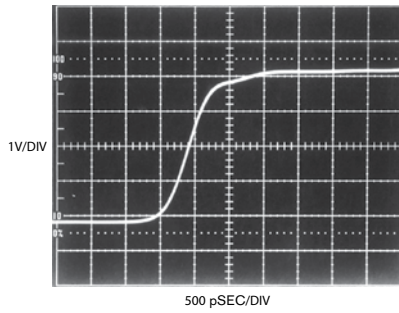
Figure D Do-it-yourself Z_0 Probe 1 introduces pulse-corner rounding, likely due to resistor/cable parasitic terms or incomplete coaxiality. Probes of this type typically manifest this type of error at rise times of less than 2 nsec.
