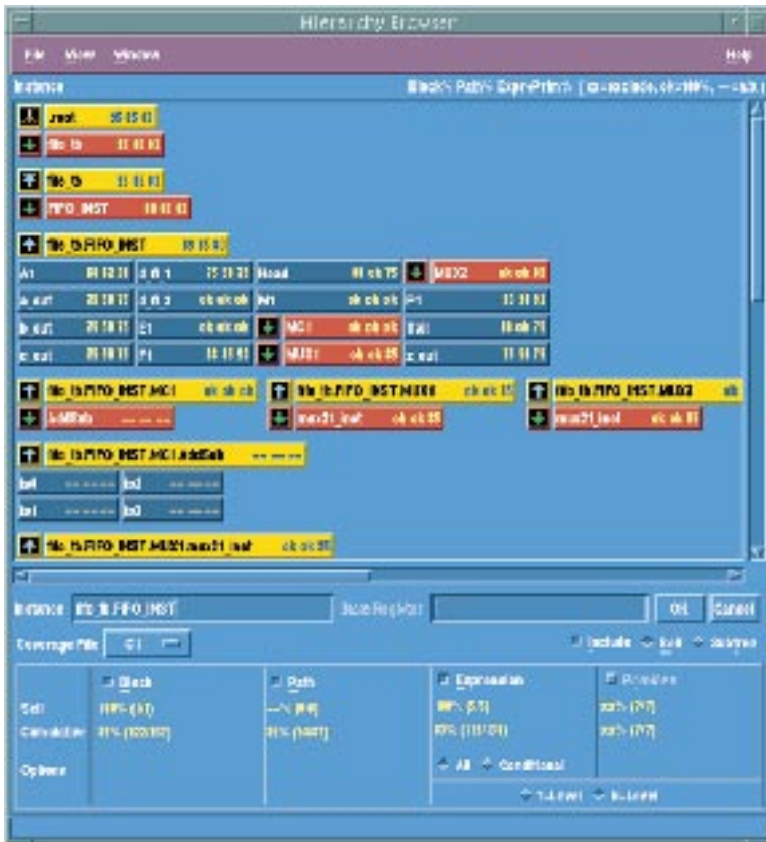
Figure 2

By analyzing code-coverage results on different pieces of your chip, you can find where “holes” exist in simulation coverage and focus your efforts on increasing design testability. In this HDLScore example, instance MUX1 in module `fifo_tb.FIFO_INST` has 100% block and path coverage but only 85% expression coverage (indicated by “ok ok 85” in the center of the figure next to `fifo_tb.FIFO_INST.MUX1`). The bottom of this photograph indicates the cumulative coverage of module `fifo_tb.FIFO_INST` as 89% block, 85% path, and 83% expression.
