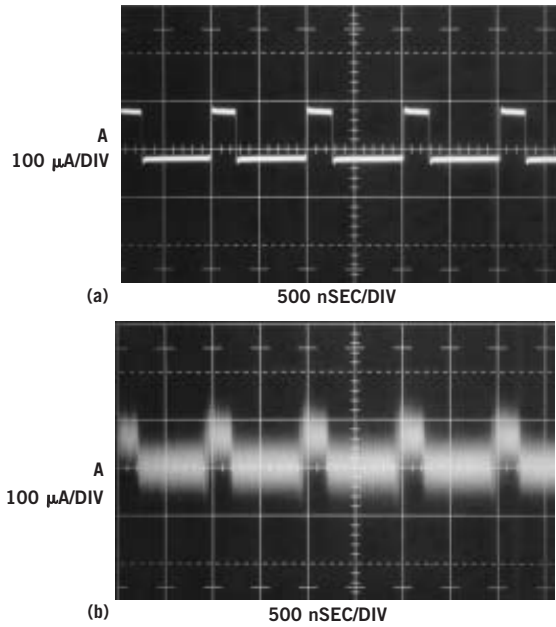
Figure A The CT-1/HP-461A combination clearly displays a 100- μ A pulse train (a). The noise floor causes the slight trace thickening. The P6022/Preamble 1855 presentation shows degraded signal-to-noise performance (b).
