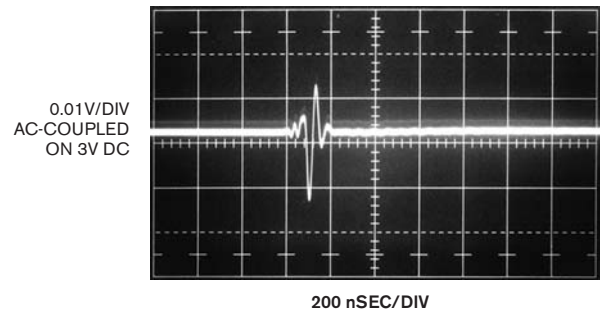
Figure A Spike measured within a continuous coaxial-signal path displays moderate disturbance and ringing after the main event.
