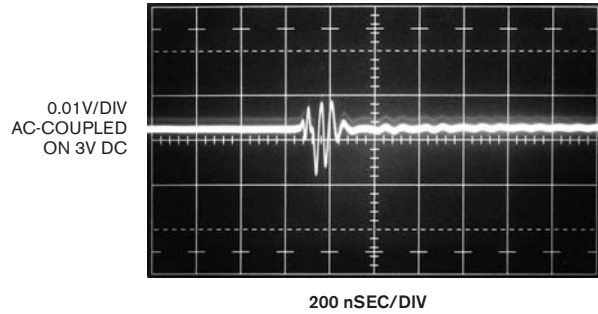
Figure B Introducing a 3-in., noncoaxial ground connection causes pronounced signal distortion and postevent ringing.
