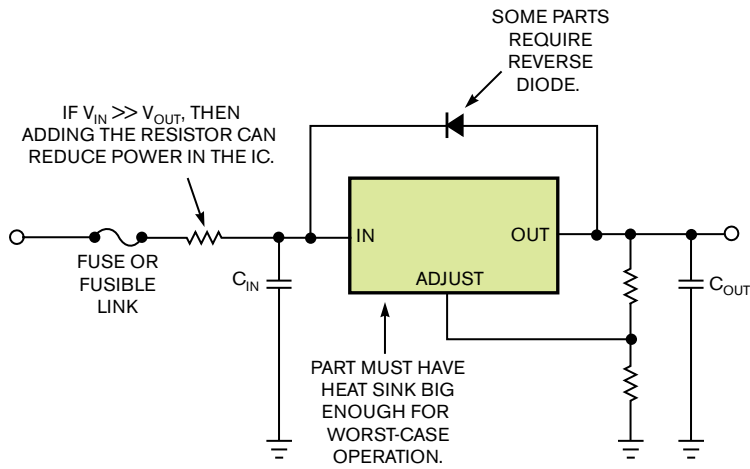
Figure 1 Linear supply problems are heat, capacitor shorting, and damage to the part when reverse currents flow inside the IC.
