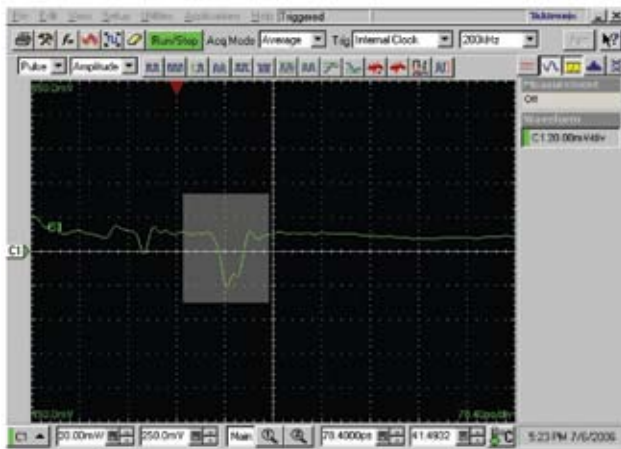
Figure 3 TDR testing of the structure in Figure 2 uses a 15-psec reflected rise time, producing these results for 1.25-mm spacing between discontinuities (a) and 2.5-mm spacing (b).
