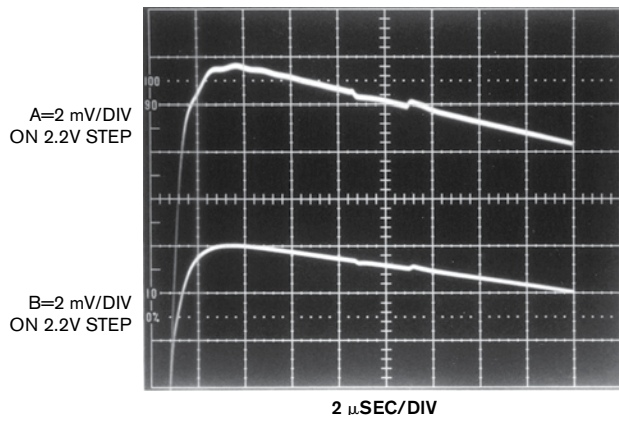
Figure 6 T_1 's primary (Trace A) and secondary (Trace B) clamping details have a highly expanded vertical scale showing the primary's and secondary's clamping flatness to be within millivolts. The trace aberrations at the center derive from S_1 's gate feedthrough.
