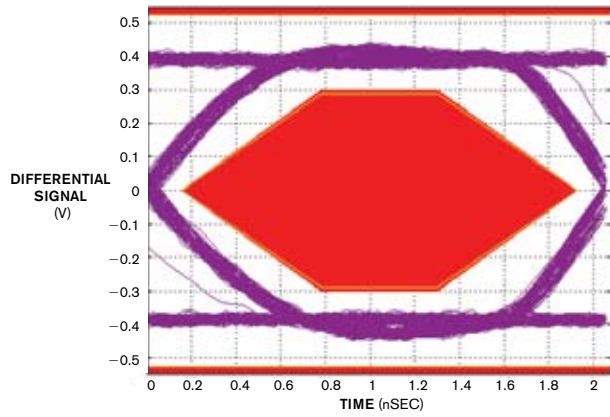
Figure 5 As little as 2-pF capacitance can cause the leading section to rise slower and round off the edge of the signal.
