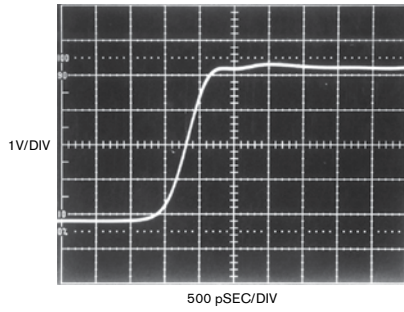
Figure C **Figure B**'s pulse viewed with a Tektronix low-impedance 500Ω P-6056 probe introduces barely discernible error.
