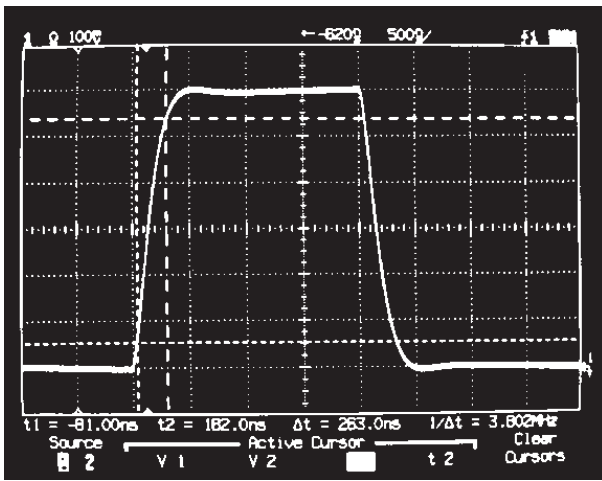
Figure 3 The circuit of Figure 2 exhibits clean pulse response with little overshoot or ringing.
